## Section 19 Flood Investigation Report

Section 19 Flood Investigation Report: Bloxham

Date of Flood Incident: 24<sup>th</sup> November 2024

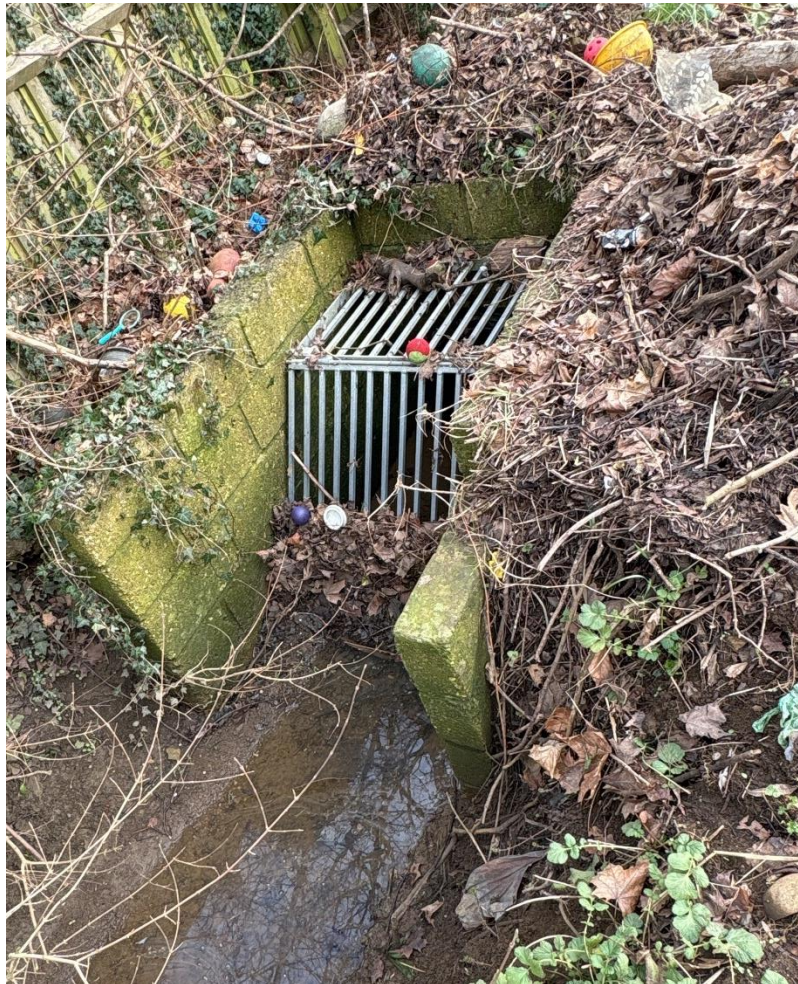
On Tadmarton Road, the site team observed a steep gradient heading north. They walked up this slope and stopped outside Bloxham Church of England Primary School, where an unnamed Ordinary Watercourse enters a culvert via a trash screen on the northern side of the road. Anecdotal reports indicated that during the November flood event, this trash screen became blocked, restricting the volume of water entering the culvert and causing water to overtop the right bank and flow southwards along Tadmarton Road. Figure 11 shows the trash screen during the site visit, with visible debris accumulation on and around it. The culverted Ordinary Watercourse then runs south along Tadmarton Road.

*Figure 11 - Trash screen at culvert inlet near Bloxham Church of England Primary School (Source: Site visit Jan 2025)*

At Tadmarton Road north, it was concluded that the sheer volume water in the catchment area led to increase river levels and overland flow, exacerbated by the blockage of a trash screen at an Ordinary Watercourse culvert inlet. This blockage caused surface water runoff to flow southwards along Tadmarton Road. Additionally, the excessive water volume caused the culverted Ordinary Watercourse on Tadmarton Road to surcharge through drains, contributing to the surface water flows. Despite limited understanding of the culverted Ordinary Watercourse, the fact that flooding has previously occurred at this location indicates a need for an investigation

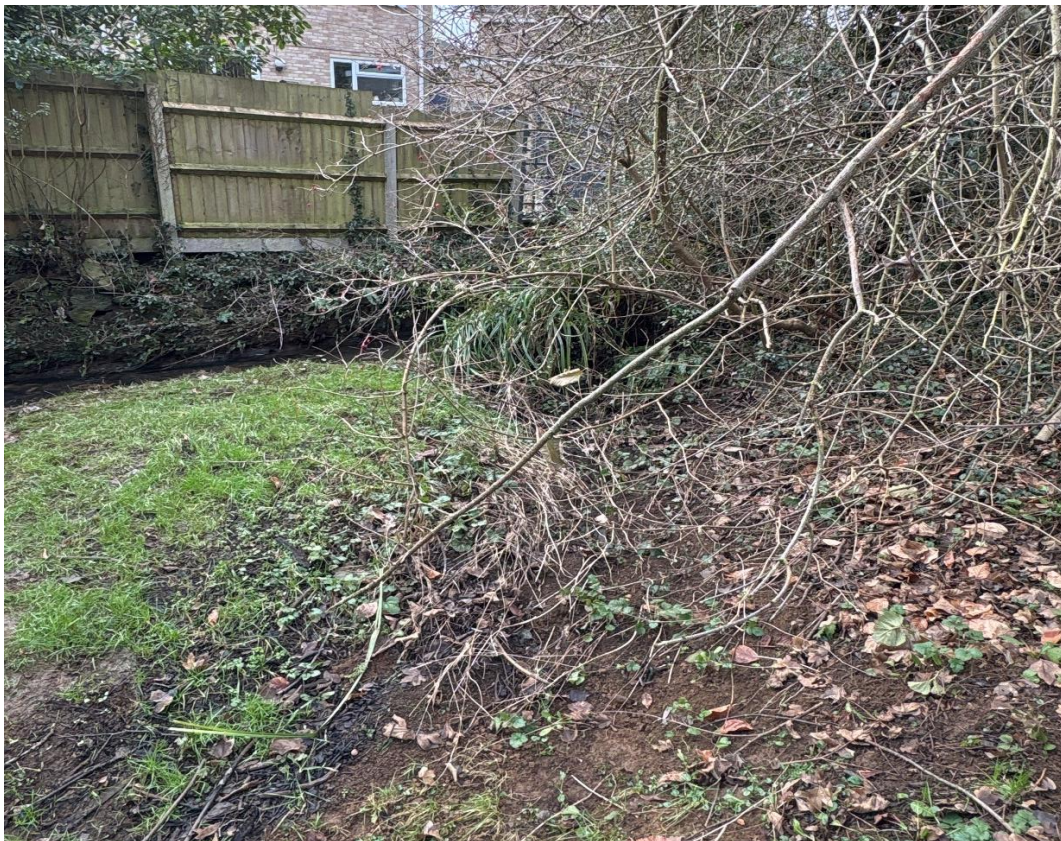
At the southern end of Tadmarton Road, the team observed the topographic low point at Bloxham Brook, situated between Tadmarton Road and Cumberford Hill, where surface water flows would likely pool. The team walked along a public footpath opposite Brookside Way, following Bloxham Brook towards Little Bridge Road. In this area, the team noted the lower-lying properties on the right bank, located in Greenshill Park. Approximately 200m from the footpath entrance, an overflow route was visible. This overflow route on the left bank provides a secondary flow path but was observed to be heavily vegetated and poorly maintained (Figure 12). A second overflow route, located 50 m downstream, was in better condition (Figure 13).

*Figure 12 - Poorly maintained overflow route on Bloxham Brook left bank (Source: Site visit Jan 2025)*

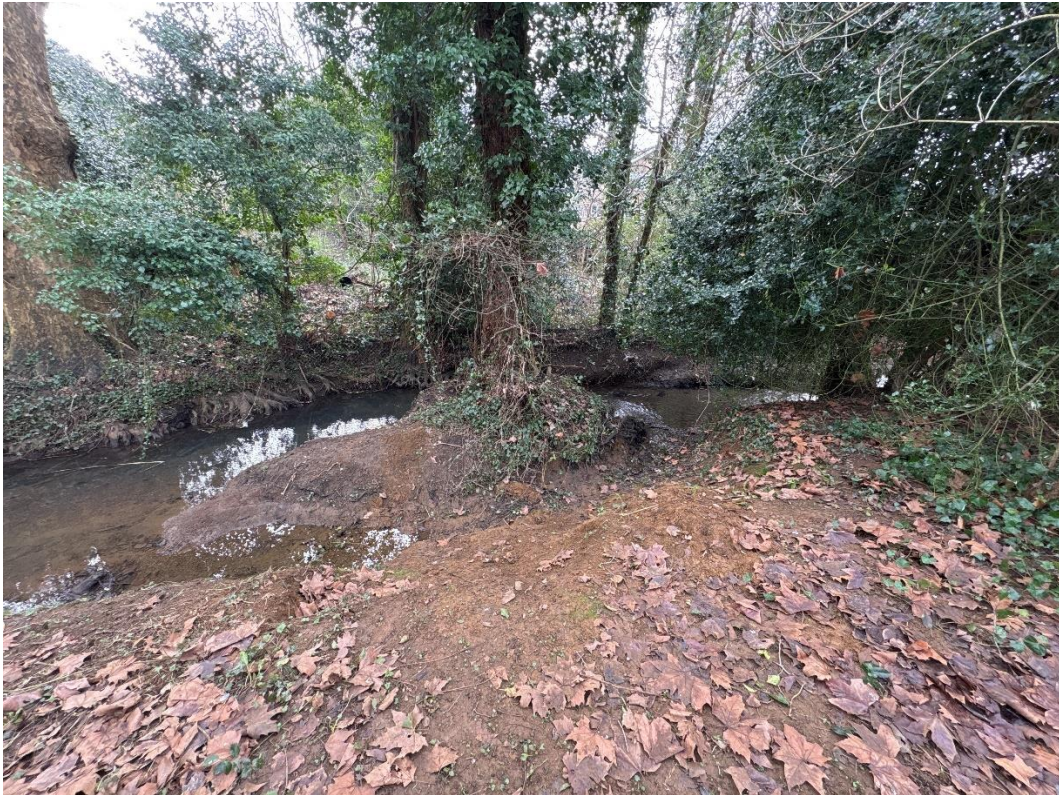
*Figure 13 - Second overflow route approximately 50m downstream of Figure 12 (Source: Site visit Jan 2025)*

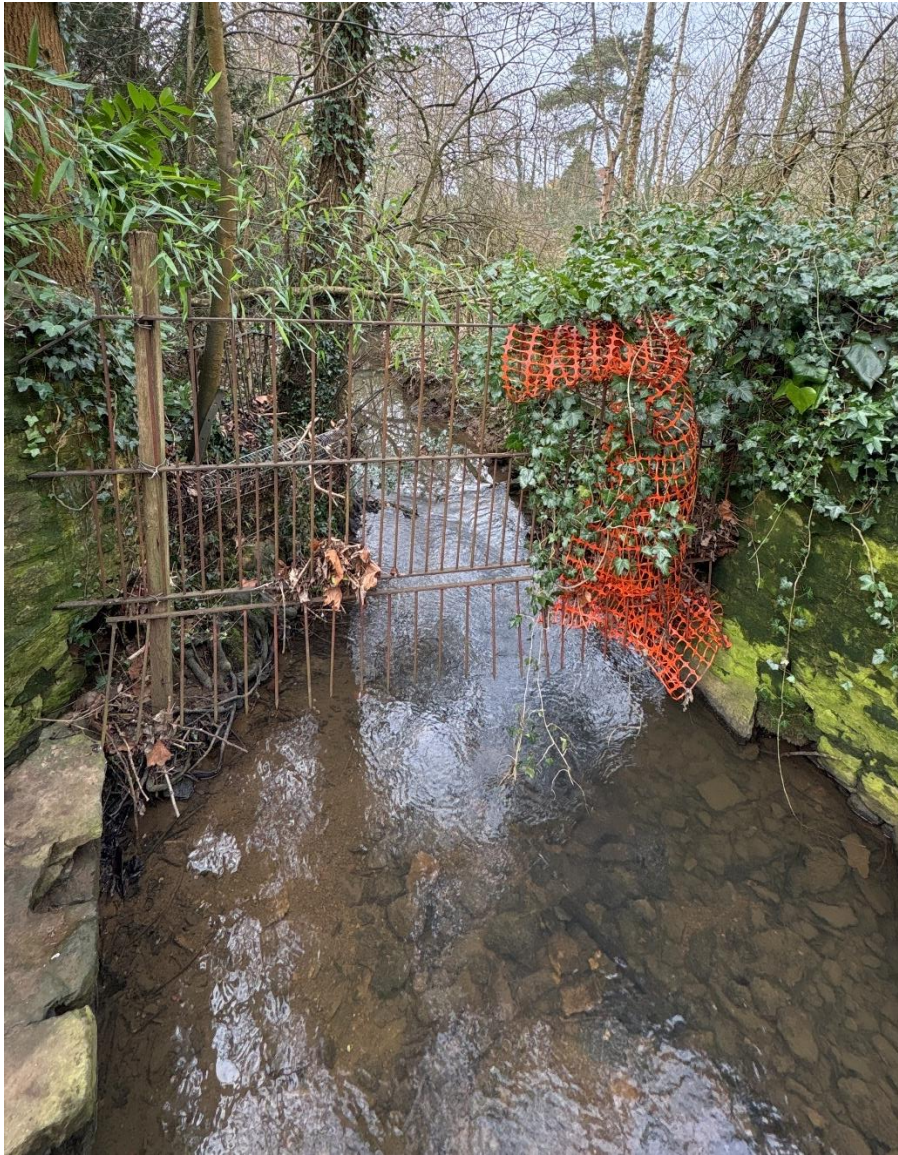
Approximately 100m downstream of Figure 13, a small footbridge is located over the Bloxham Brook. The site team noted an informal trash screen located just upstream of the bridge, visible in Figure 14. While the screen was in fair condition, regular maintenance to remove debris would maximise water conveyance during high flows. Additionally, the bottom rung of spikes appeared weak and could potentially be damaged during a high flow event.

*Figure 14 - Trash screen upstream of the footbridge (Source: Site visit Jan 2025)*

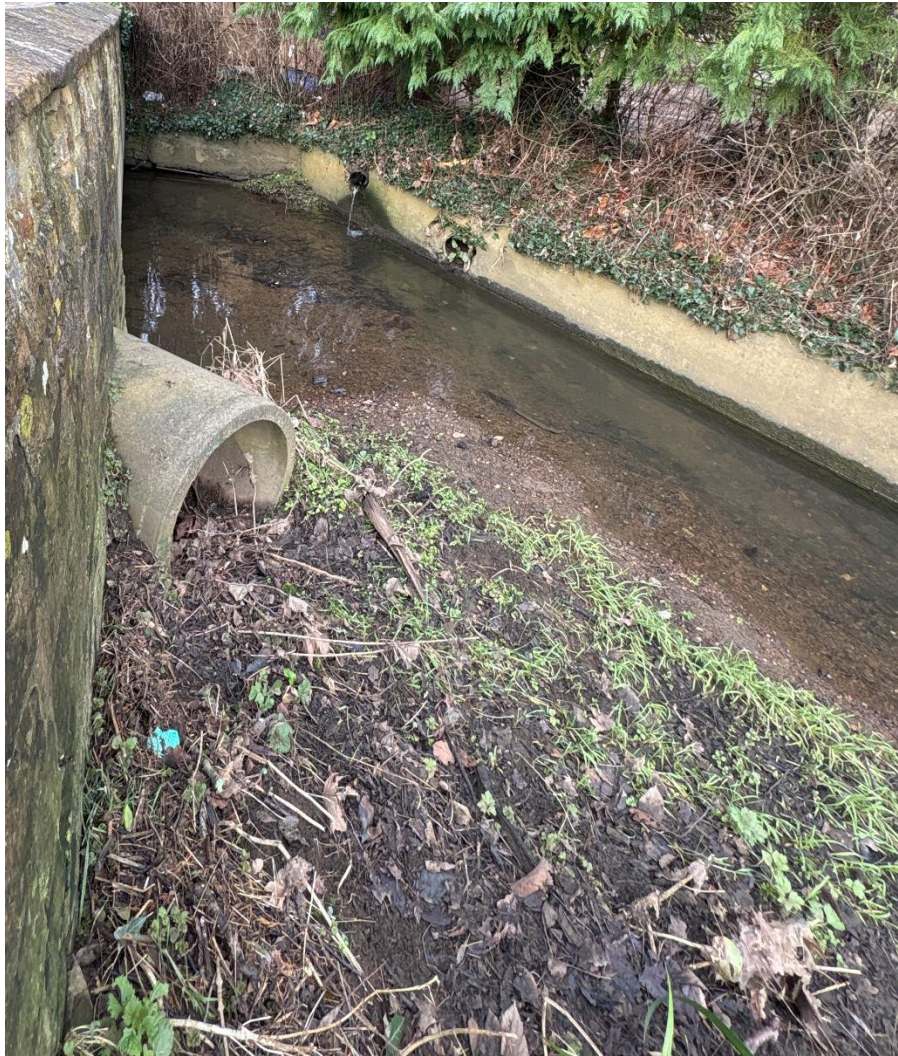
At Little Bridge Road, the site team observed Bloxham Brook flowing under a small bridge. While the upstream side of the bridge was well maintained, the relief culvert on the right bank was partially blocked with silt and debris. The outlet of this culvert, visible on the downstream side of the bridge, was also heavily silted, reducing the capacity of both the channel and the culvert (Figure 15). Additionally, the team noted the gradient of the road on either side of the bridge, with steep slopes leading towards the topographic low point of Bloxham Brook.

*Figure 15 - Relief culvert outlet (Source: Site visit Jan 2025)*

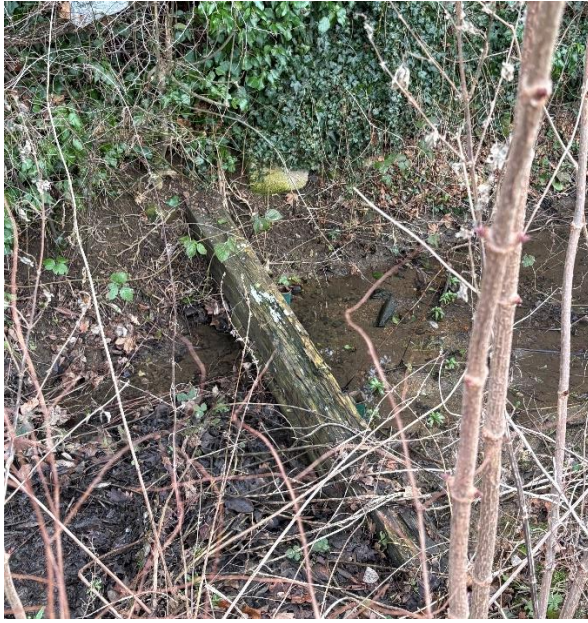
The site team walked along Courtington Lane, noting the steep gradient across the school playing fields up to the topographic high point of Hobb Hill. At the eastern edge of the fields, the team observed an Ordinary Watercourse, which is believed to channel runoff from Hobb Hill into the highways drainage system. In the open channel section of this Ordinary Watercourse, the team saw some wooden baffle boards intended to attenuate flow (Figure 16). While these baffles would impact conveyance, they were observed to be low. Investigating the effectiveness and possible improvements to these baffles could help maximise flow attenuation in the future. This watercourse is then culverted at the southeastern extent of the field, with the inlet and a trash screen visible. The trash screen was observed to contain some debris (Figure 17).

Figure 16 - Wooden baffle boards in Ordinary Watercourse (Source: Site visit Jan 2025)

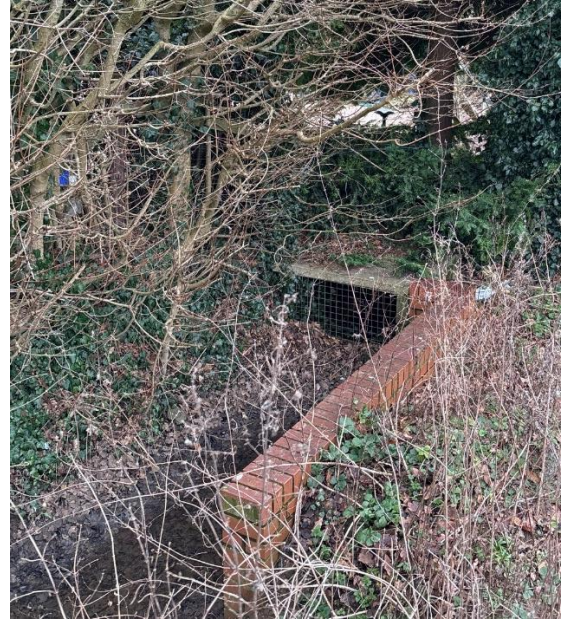
Figure 17 - Culvert inlet and trash screen in Ordinary Watercourse (Source: Site visit Jan 2025)

The culverted watercourse visible in Figure 17 then joins the highways drainage network along Courtington Lane. The site team observed the outfall of this culvert through an open drain on Courtington Lane. Discussions were had around the culvert survey, which showed that the culvert continues towards Workhouse Lane with an inlet width of 375mm. At the corner of Workhouse Lane, this 375mm box culvert feeds into a 150mm culvert, which then runs eastwards under properties before feeding into a 225mm culvert owned by Thames Water on High Street. As mentioned in Section 2.1.4 a culvert survey was undertaken in January 2025 in this location to investigate concerns regarding capacity. Although the culvert survey showed no signs of a blockage, the reduction in capacity from a 375mm culvert to a 150mm culvert is likely the cause of flooding in the Workhouse Lane area during the November flood event. While the initial thought might be to increase the size of the 150mm culvert to improve capacity, the outfall of this 150mm culvert being 225mm means measures must be taken to ensure the flooding issue is not simply transferred downstream. It also means any benefit of upsizing the 150mm culvert is likely to be limited, as a flow constriction will still occur downstream at the 225mm culvert. At the downstream extent on High Street, the route of the surface water drainage into Bloxham Brook is not fully known. Therefore, an investigation into the surface water drainage along High Street by both Thames Water and the OCC highways is recommended.
