## Section 19 Flood Investigation Report

Section 19 Flood Investigation Report: Bloxham

Date of Flood Incident: 24<sup>th</sup> November 2024

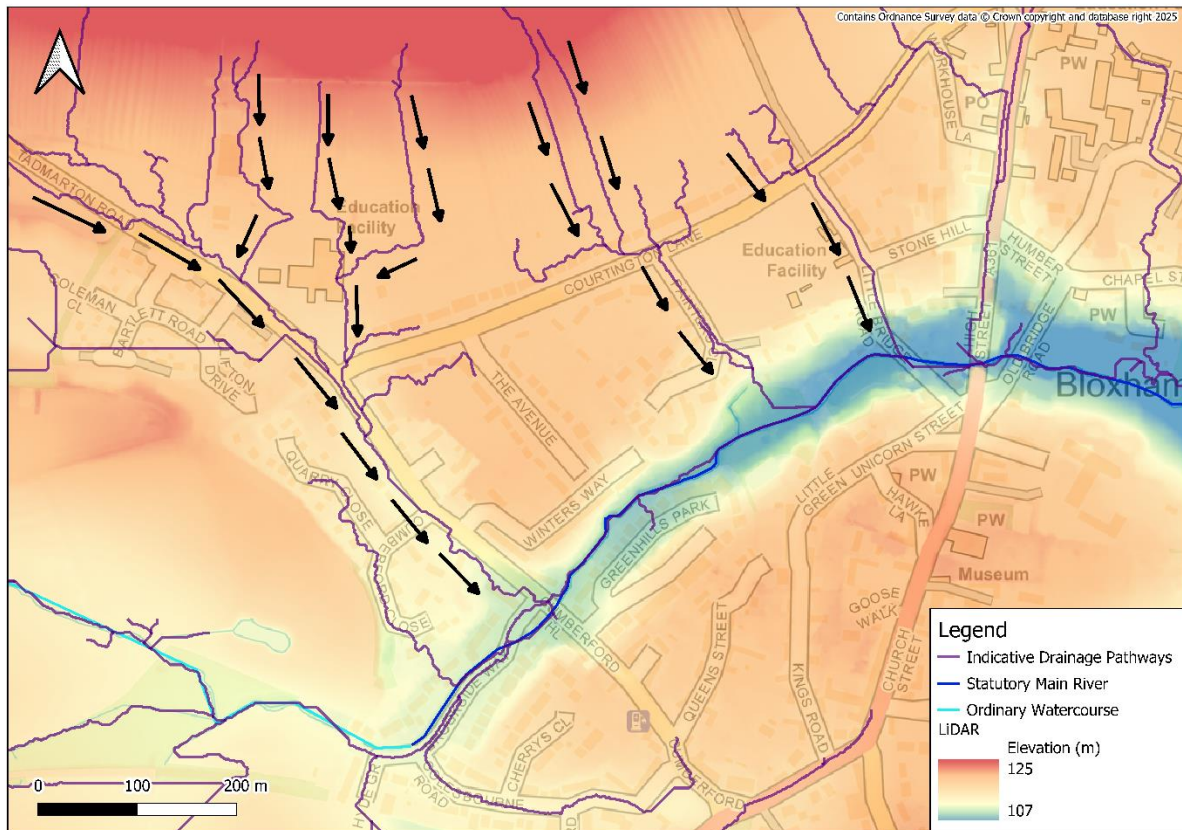
Figure 5 - Indicative overland flow pathways near Tadmarton Road north, Tadmarton Road south and Little Bridge Road. Data from [DEFRA Data Services Platform](#) (2025)

Figure 5 shows the indicative overland flow pathways near Tadmarton Road north, Tadmarton Road south, and Little Bridge Road. Water flows from the topographic high point of Hobb Hill, visible at the northern extent of Figure 5, and follows the natural shape of the land toward the village, via an unmapped Ordinary Watercourse along Tadmarton Road. Flows are also visible running southeast along Tadmarton Road

towards the topographic low point at Bloxham Brook, and similarly southwards along Little Bridge Road and Painters Close towards Bloxham Brook.

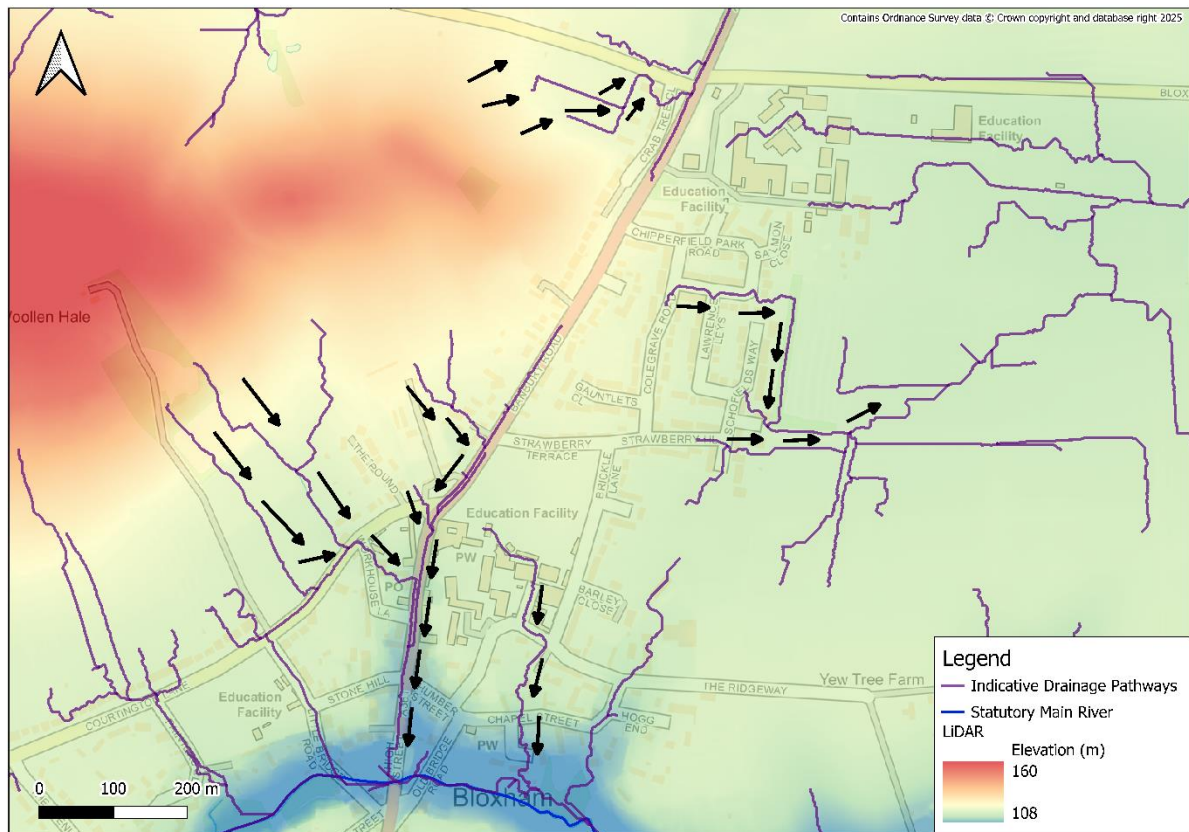
Figure 6 - Indicative overland flow pathways near Steeple Close, Workhouse Lane, Greens Garth and Crab Tree Close Data from [DEFRA Data Services Platform](#) (2025)

Figure 6 shows the indicative overland flow pathways near Workhouse Lane, Steeple Close, Greens Garth and Crab Tree Close. Water flows from the topographic high point of Hobb Hill south before entering an unmapped Ordinary Watercourse in the fields north of Courtington Lane. Flows then continue towards Courtington Lane and Workhouse Lane before flowing south along High Street (A361). Near Steeple Close, water flows southwards through Chapel Street and onto Steeple Close before entering the Bloxham Brook. At Greens Garth, water flows from west to east along Strawberry Hill, as well as southwards behind properties on Schofields Way. At Crab Tree Close, flow pathways follow the gradient downhill from Hobb Hill towards an unmapped Ordinary Watercourse before entering Crab Tree Close at its north easterly extent.

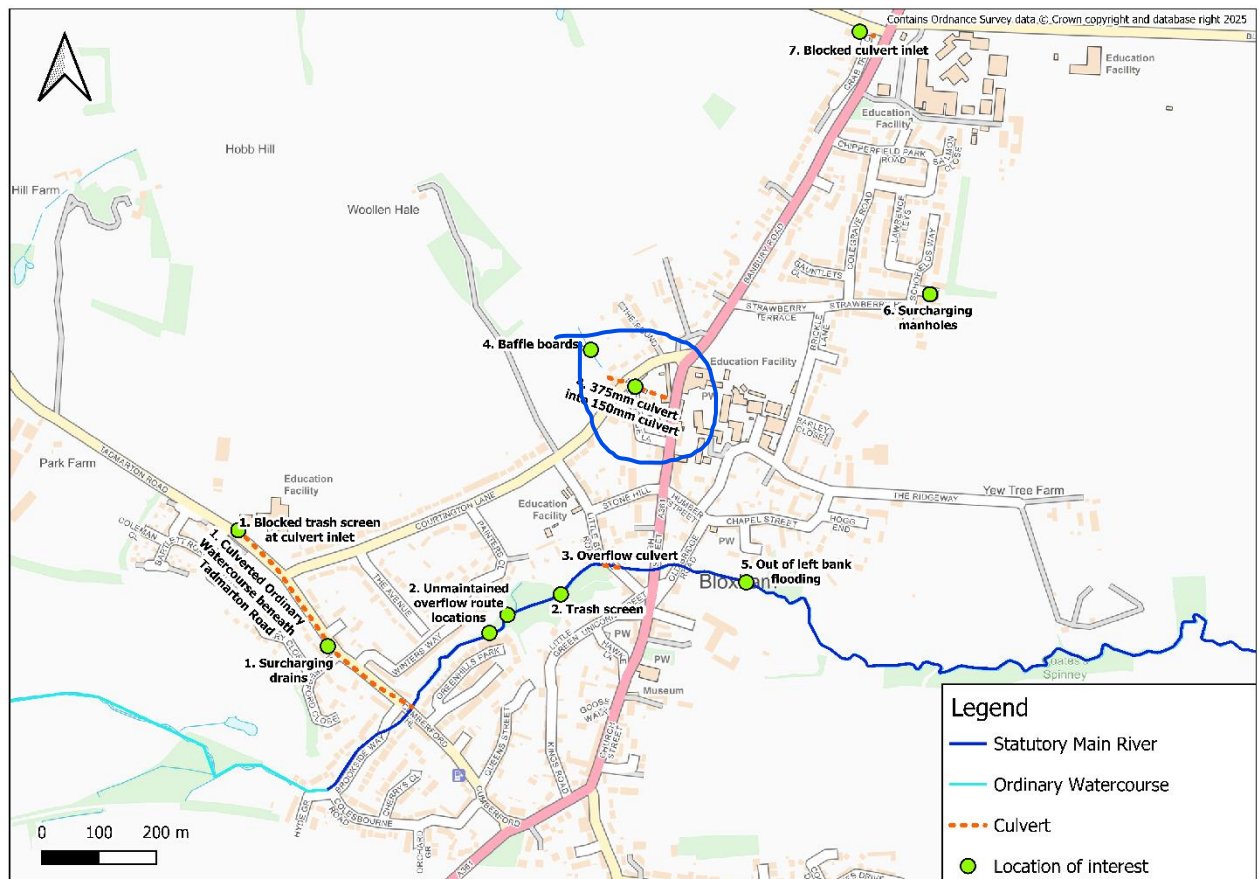
Figure 7 - Map displaying approximate locations of previously unmapped culverts and locations of interest (Source: Site visit Jan 2025)

Figure 7 displays approximate locations of culverts and locations of interest throughout Bloxham, with a label referencing the relevant number related to the below sections. It is important to note that as culvert lengths were previously unmapped and as such the extents displayed in Figure 7 are an approximation.

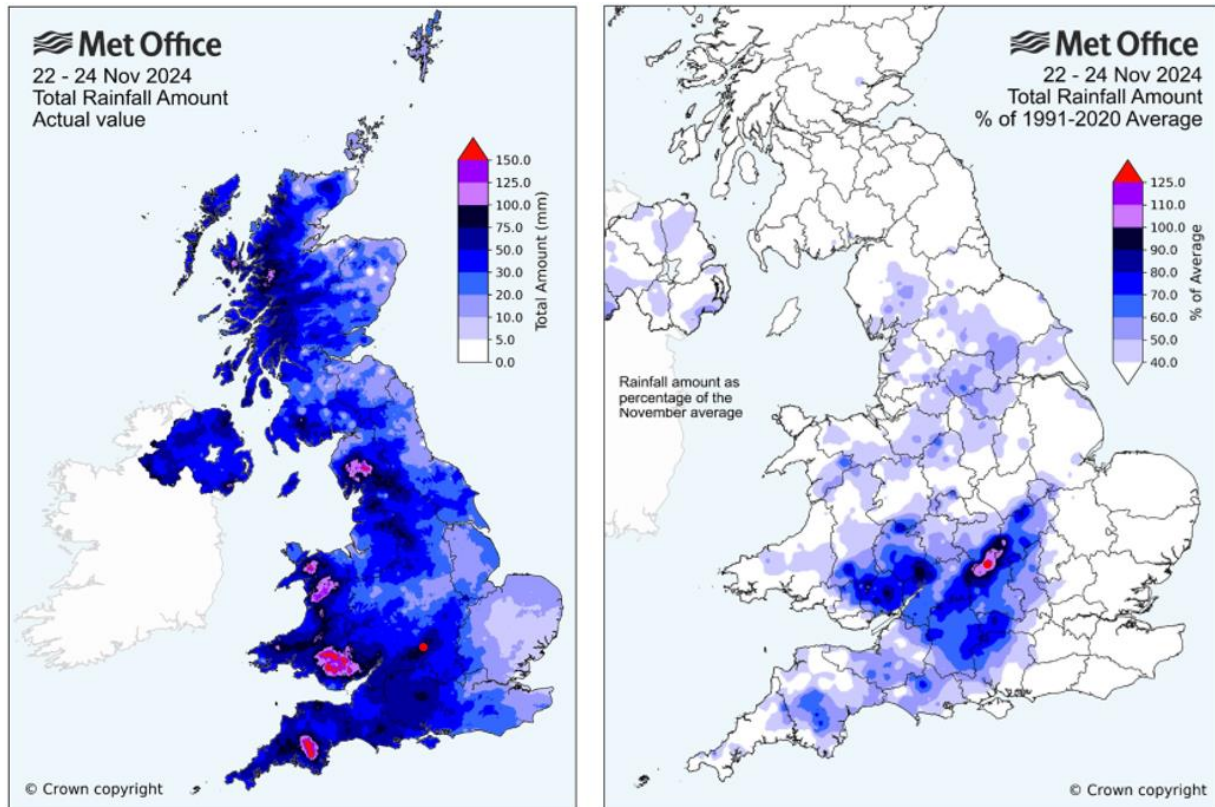
Figure 8 – 22<sup>nd</sup>-24<sup>th</sup> November total rainfall amount (left) and % of 1991-2020 November average (right). Red dot = Bloxham approx. location (Met Office, 2024).

As mentioned in Section 2.1, across the three day period of 22<sup>nd</sup>-24<sup>th</sup> November, the Met Office reported that Oxfordshire received their monthly rainfall average or more (Figure 8). Many parts of the county received particularly heavy rainfall on these dates, with the UK recording its wettest calendar day on 23<sup>rd</sup> November– as an average across the whole country – since 3<sup>rd</sup> October 2020.

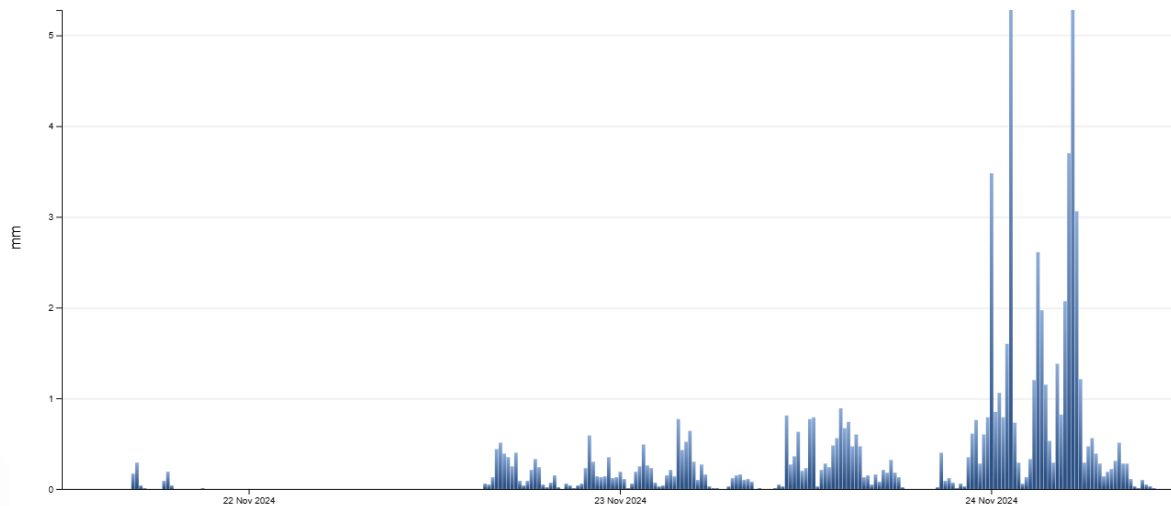
Figure 9 – Checked total recorded rainfall at Chipping Norton Gauge 22<sup>nd</sup> – 24<sup>th</sup> November in 15 min intervals (DEFRA 2025 [Accessed: 06/05/2025]).

To explore rainfall in Bloxham, data has been obtained from the Department for Environment Food & Rural Affairs' Hydrology Data Explorer<sup>3</sup>. At the Grimsbury rain gauge, the nearest to Bloxham (7km to the northeast) approximately 68mm of rain fell across November 23<sup>rd</sup>-24<sup>th</sup>, with a 15-minute maximum of 5mm falling at 1pm on the November 24<sup>th</sup> (Figure 8, Figure 9). The daily rainfall total of 47mm on the 24<sup>th</sup> of November is the ninth highest since records began at Grimsbury gauge in December 1989. It is worth noting that this data has been checked by DEFRA confirming its accuracy and reliability.

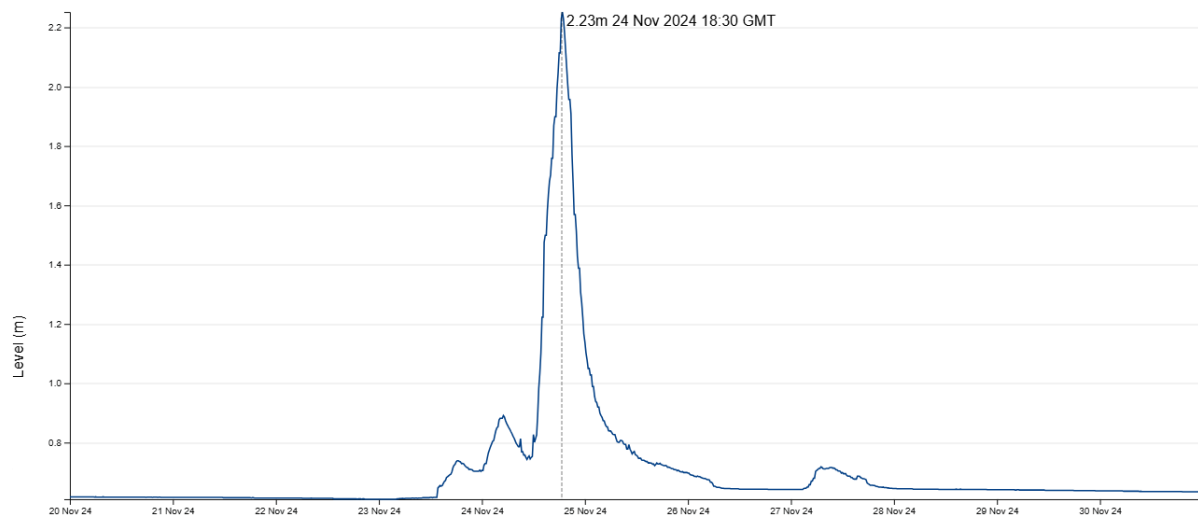
Figure 10 – Checked river levels in the Bloxham Brook prior to, during and flooding the flood event – maximum level peaking a 2.2m (DEFRA 2025 [Accessed: 06/05/2025]).

The river levels recorded at the Bloxham Brook river level gauge show the effects of the prolonged rainfall event (Figure 10). Prior to the rainfall event, river levels in the Bloxham Brook recorded around 0.6m before steadily increasing on the morning of the 23<sup>rd</sup> of November, drastically peaking in the afternoon of the 24<sup>th</sup> at a 2.2m. It is worth noting that this data has been checked by DEFRA confirming its accuracy and reliability.

The data presented here supports the suggestion that county-wide intense rainfall on the 23<sup>rd</sup> and 24<sup>th</sup> of November was the primary cause of flooding in Bloxham. The heavy rainfall likely followed the indicative drainage pathways shown in Figures 5, and 6 making its way to Bloxham Brook, which had already collected rainfall from its upstream catchment. Consequently, Bloxham Brook experienced an increase in river flow and level due to the rainfall, likely raising the risk of out of bank fluvial flooding. The low points of Bloxham throughout the village are key locations where fluvial and surface waters can interact, further exacerbating the flooding risk.
